South Coast  
**Home ✓ Check**

## **PROPERTY INSPECTION REPORT**

**YOUR REF + REPORT No: 7217**

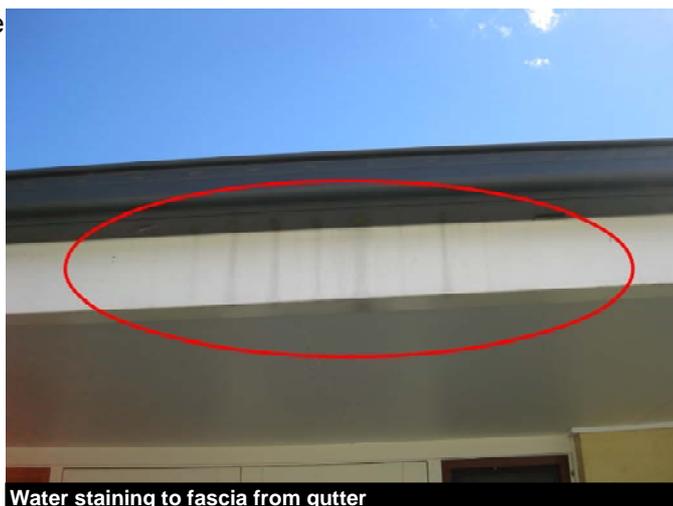
**Roof guttering appears to be a high front profile. It is recommended to have a licenced plumber further inspect and recommended some modifications to assist in mitigating backflow into the eaves & wall cavity.**

**Evidence of overtopping was identified several sections of the exterior in the form of light water staining to the roof fascia.**

**2.7 The following action is recommended:**

A licensed roof plumber should be called to make a further evaluation and repairs or rectification as needed.

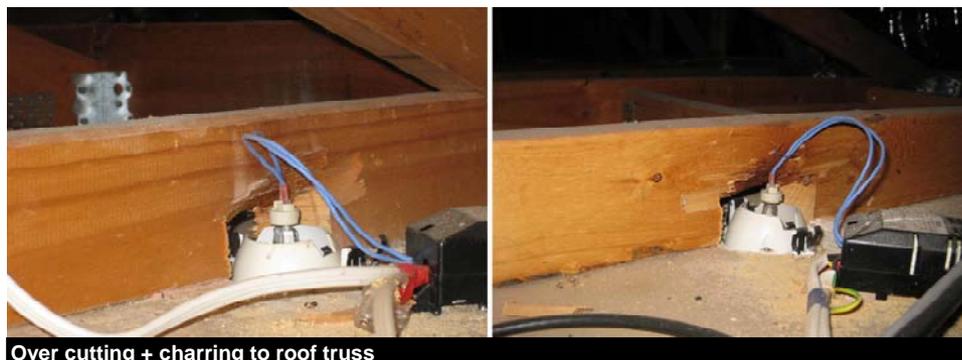
The timber truss roof system is adequate for the roof covering apart from the areas outlined below.

**One identified truss bottom chord has been over-cut to accommodate recessed halogen down lighting. The extent of this over cutting has compromised the structural integrity of the affected roof truss. The lights will need to be removed and the trusses repaired accordingly. This will need to be done before occupation.**

3.4 The following action is recommended:

A licensed carpenter should be called to make a further evaluation and repairs or rectification as needed. A licensed electrician should be called to make a further evaluation and repairs or rectification as needed.

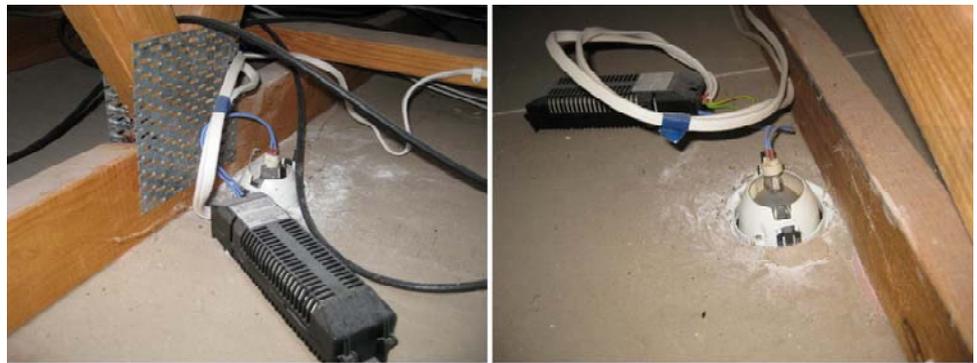
**Several recessed halogen downlights are in close proximity and/or contact with timber framing members. This will need to be rectified before occupation so as to afford an acceptable level clearance between the lighting and timber framing.**

Insufficient clearance between light and framing timbers.

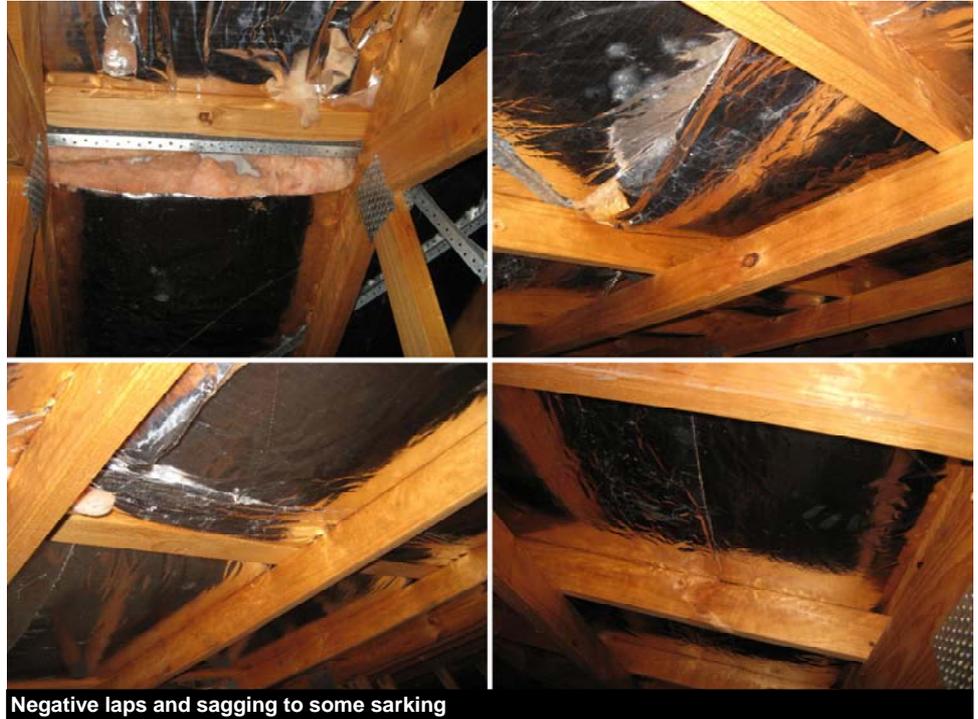
Sarking & thermal insulation has been fitted under the roof covering in the form of anti-condensation blanket.

**Some localised sections of the any condensation blanket have a negative lap and/or sagging. This may result in condensation entering the roof cavity. Repairs are required.**

**3.7 The following action is recommended:**

A licensed roofing contractor should be called to make a further evaluation and repairs or rectification as needed.

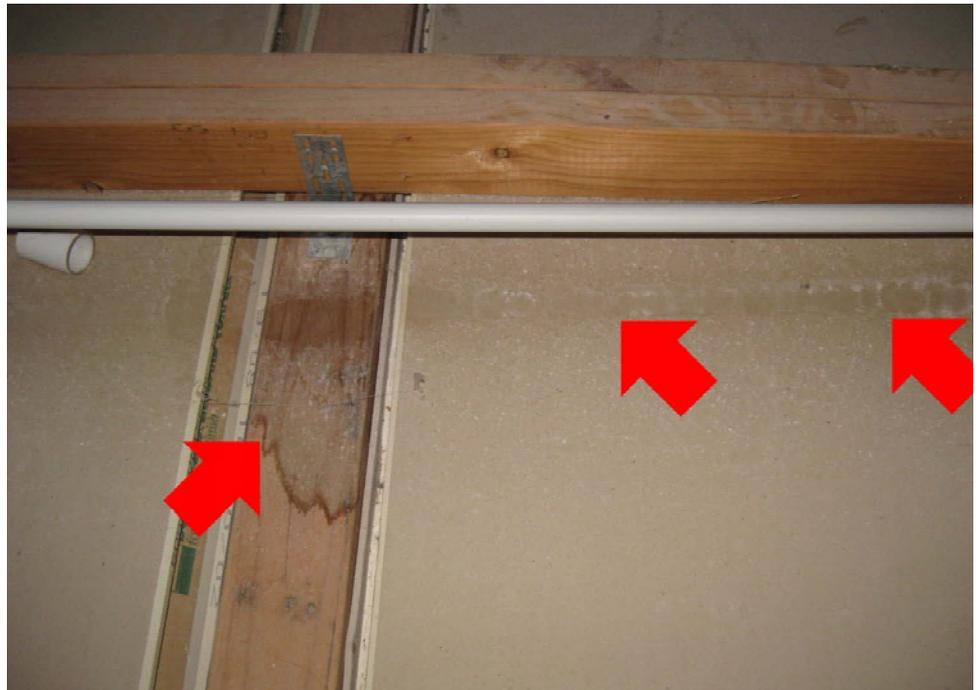
**Water staining and drip lines from air-con**  
No visible leakage was identified at the time of this inspection. **However it should be noted that condensation drip line from the air-conditioning unit located in the ceiling cavity was noted. This will need to be rectified.**

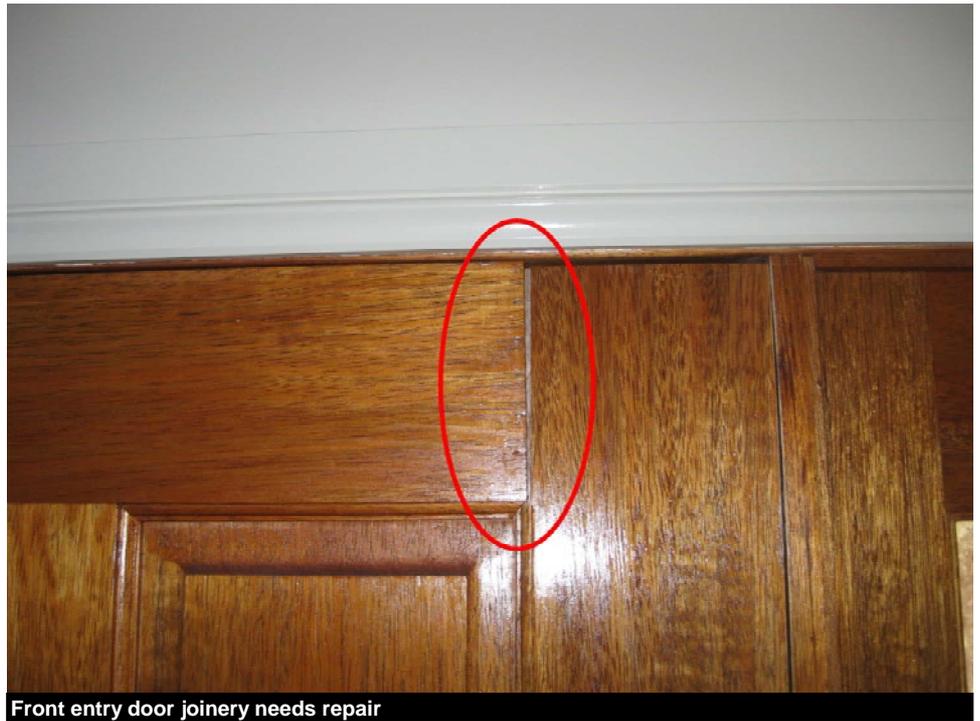
Front entry door joinery needs repair

**The front entry door requires some repairs to joinery.**

**The gapping under the front entry threshold to be suitably trimmed. This threshold may be deemed a trip hazard and may need further modification.**

### 4.8 The following action is recommended:

A licensed carpenter should be called to make a further evaluation and repairs or rectification as needed.

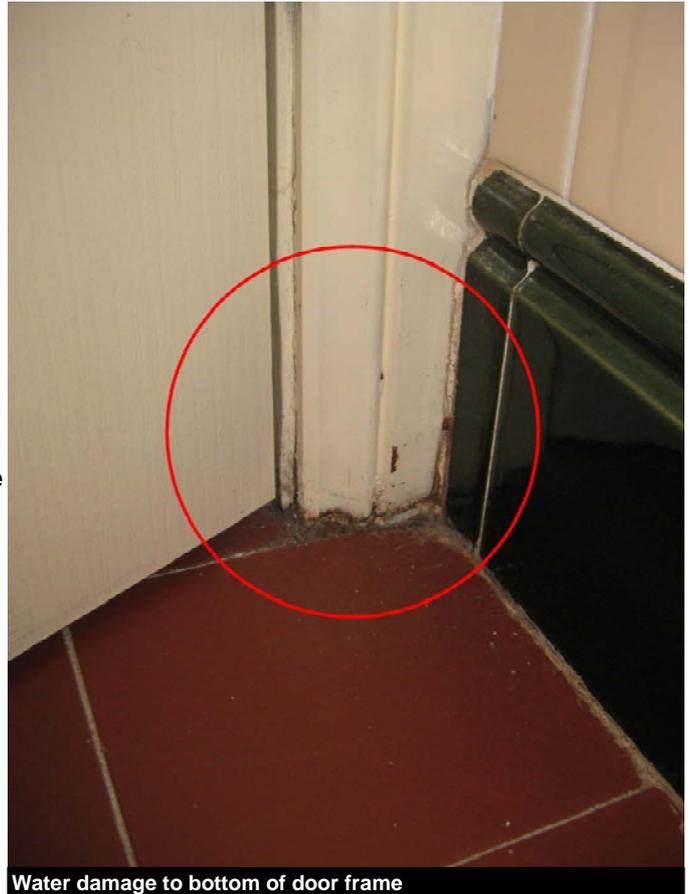
**Water is leaking under the shower screen and should be resealed to the floor and walls.**

**Moisture damage is evident to the bottom of the bathroom doorway architrave.**

Water damage to bottom of door frame

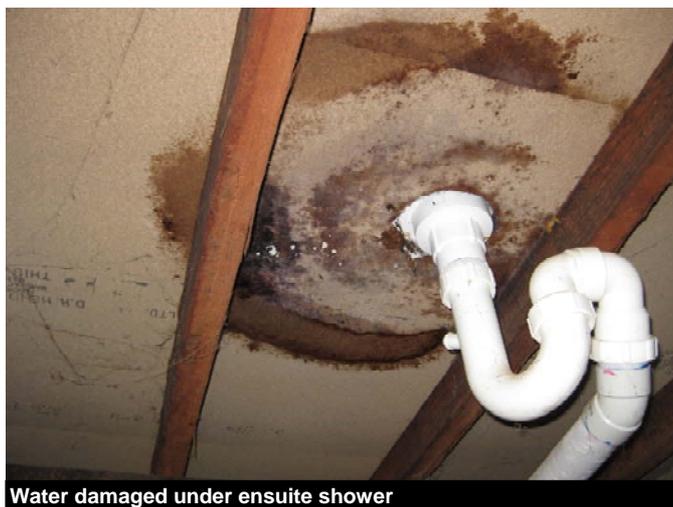
**The shower recess is leaking. Continued leakage may allow damage to surrounding components, of which is occurring. Rectification will be required and the extent of works should be determined by a Licensed Builder.**

**Moisture damage is evident to the bottom of the ensuite doorway revealed.**

Water damaged under ensuite shower

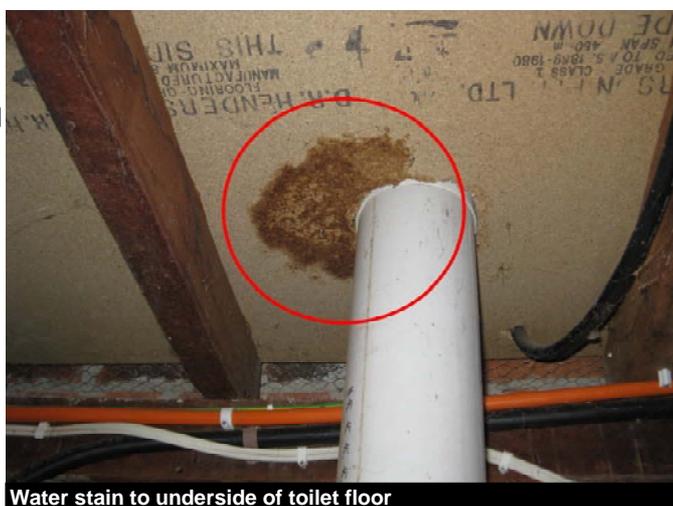
**Water staining was noted to the flooring to the underside of this toilet pan. Moisture meter readings were acceptable at the time of inspection however further inspection is required to ascertain if the leak is active.**

Water stain to underside of toilet floor

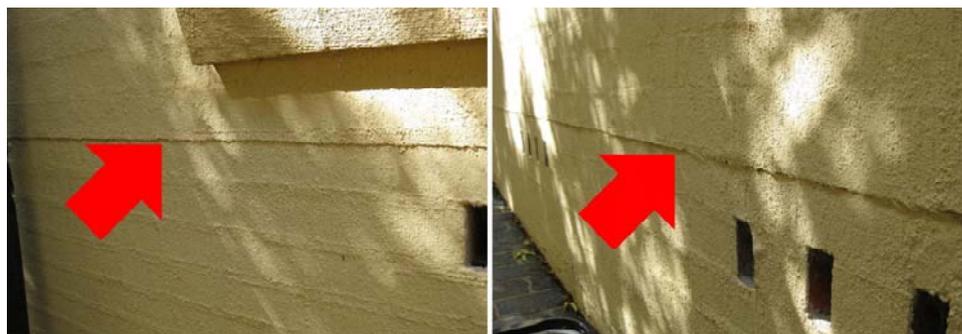
Lateral movement at damp course height

Cracks/movement are evident to the exterior brickwork at damp course level along with several hairline cracks to various sections of the exterior brickwork. Visible cracking has been categorized as an appearance defect. Cracking of a building element is an appearance defect where in the opinion of the inspector the appearance of the element is blemished however, the expected consequence of this cracking is unknown until further information is obtained. The cause of the cracking appears to be due in part to brick growth and expansion within the masonry walls.

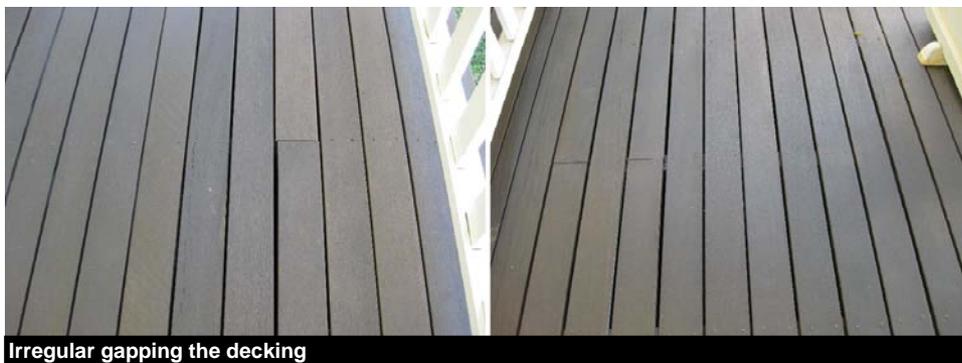
**Irregular gapping the decking**

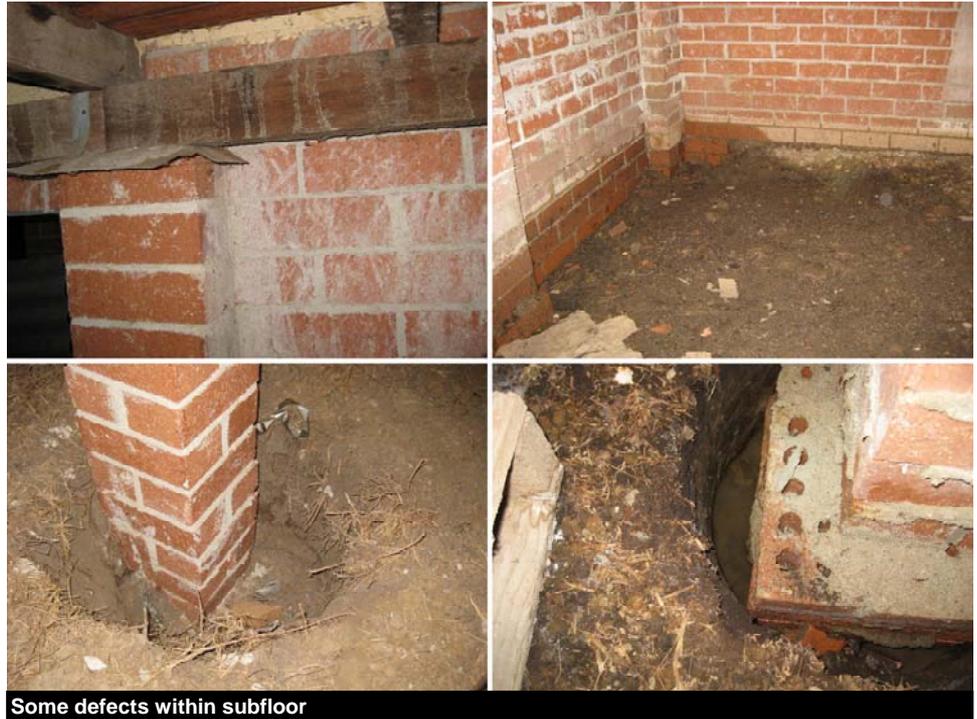
Some defects within subfloor

No all areas have ant caps fitted. The purpose of antcapping is to prevent concealed termite entry by forcing the termites build mud tunnels around the visible sections of the antcapping enabling detection during a pest inspection. Antcapping will not prevent the entry of termites to a structure however, correctly fitted ant caps will assist in early detection. If it is not possible or practicable to fit antcapping, this area should be regularly inspected by a Timber Pest Inspector.

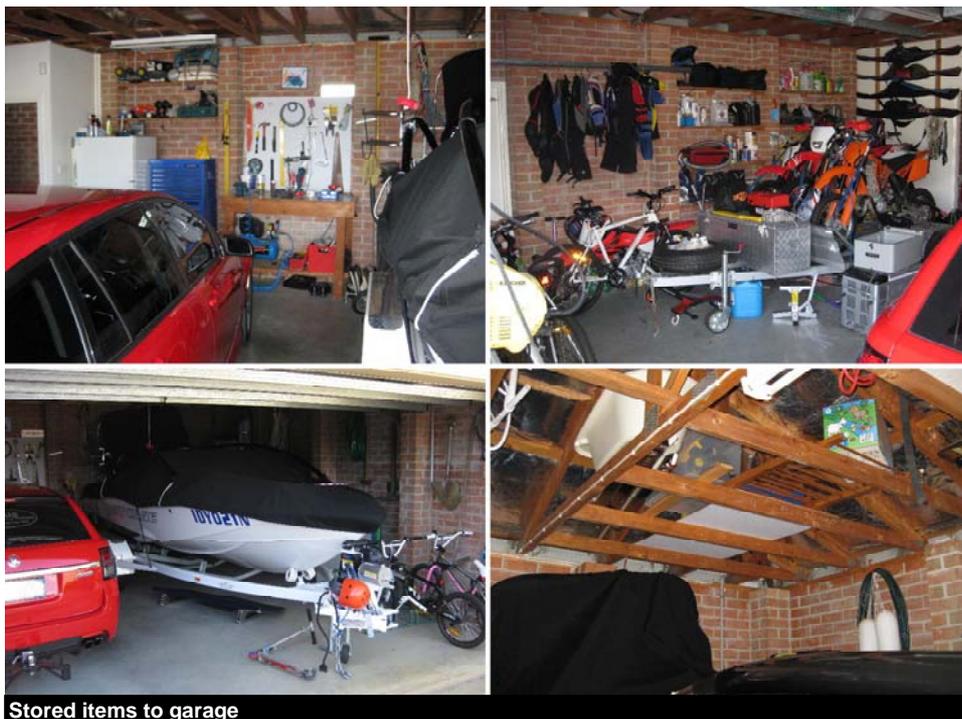
Stored items to garage

Access to the rear and eastern side to the garage was restricted by stored items and encumbered access.

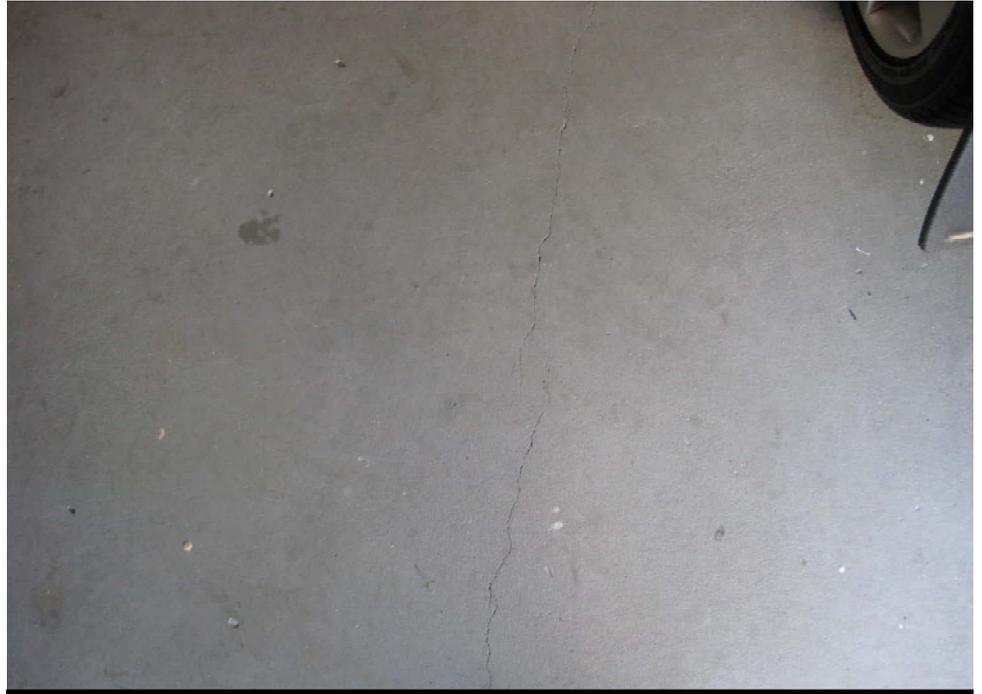
**Appearance cracking to garage floor**

Cracks are evident to the garage floor. Visible cracking has been categorized as an appearance defect. Cracking of a building element is an appearance defect where in the opinion of the inspector the appearance of the element is blemished however, the expected consequence of this cracking is unknown until further information is obtained.

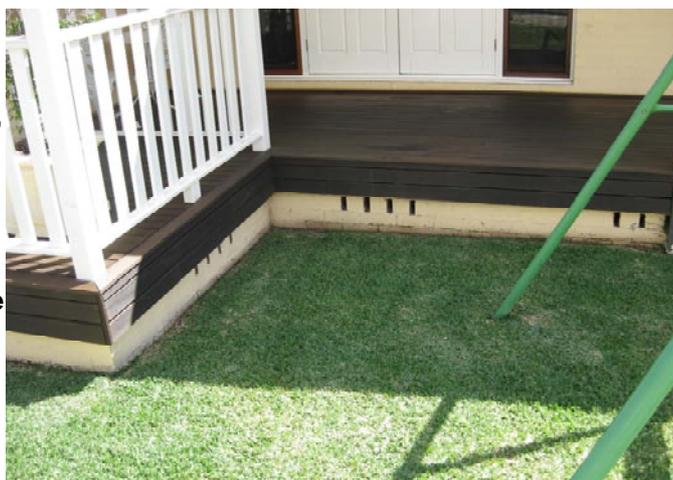
The drainage at the right (eastern) side of the property appears inadequate (. As a result, evidence suggests that surface water has been ponding. Poor site drainage can create unstable foundations that may have an adverse structural effect over time. Rectification is required. Drains should be installed to divert seepage and surface runoff water away from the house. The drains

Evidence of ponding east side of house

should be connected to the existing stormwater drainage system. Please contact a Licensed Landscaper or Builder for further information.

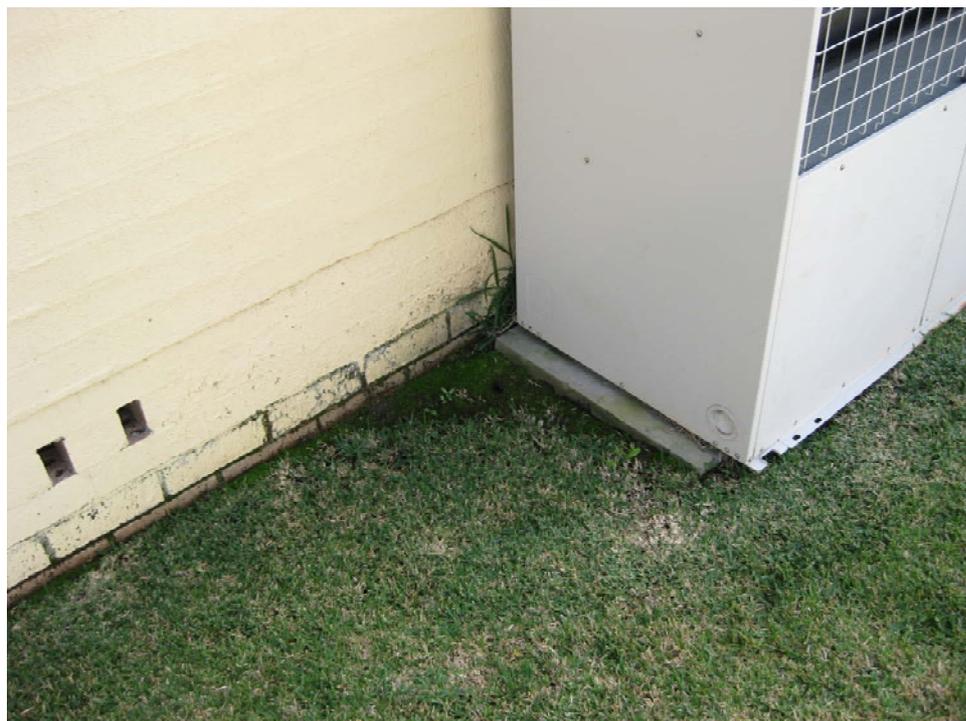
Due to inadequate drainage, ground water is ponding or flowing within the subfloor area. Poor site drainage can create unstable foundations that may have an adverse structural effect over time. Rectification is required. Drains should be installed to divert seepage and surface runoff water away from the house. The drains should be connected to the existing stormwater drainage system. Please contact a Licensed Landscaper or Builder for further information.

Evidence of ponding around air-conditioning.

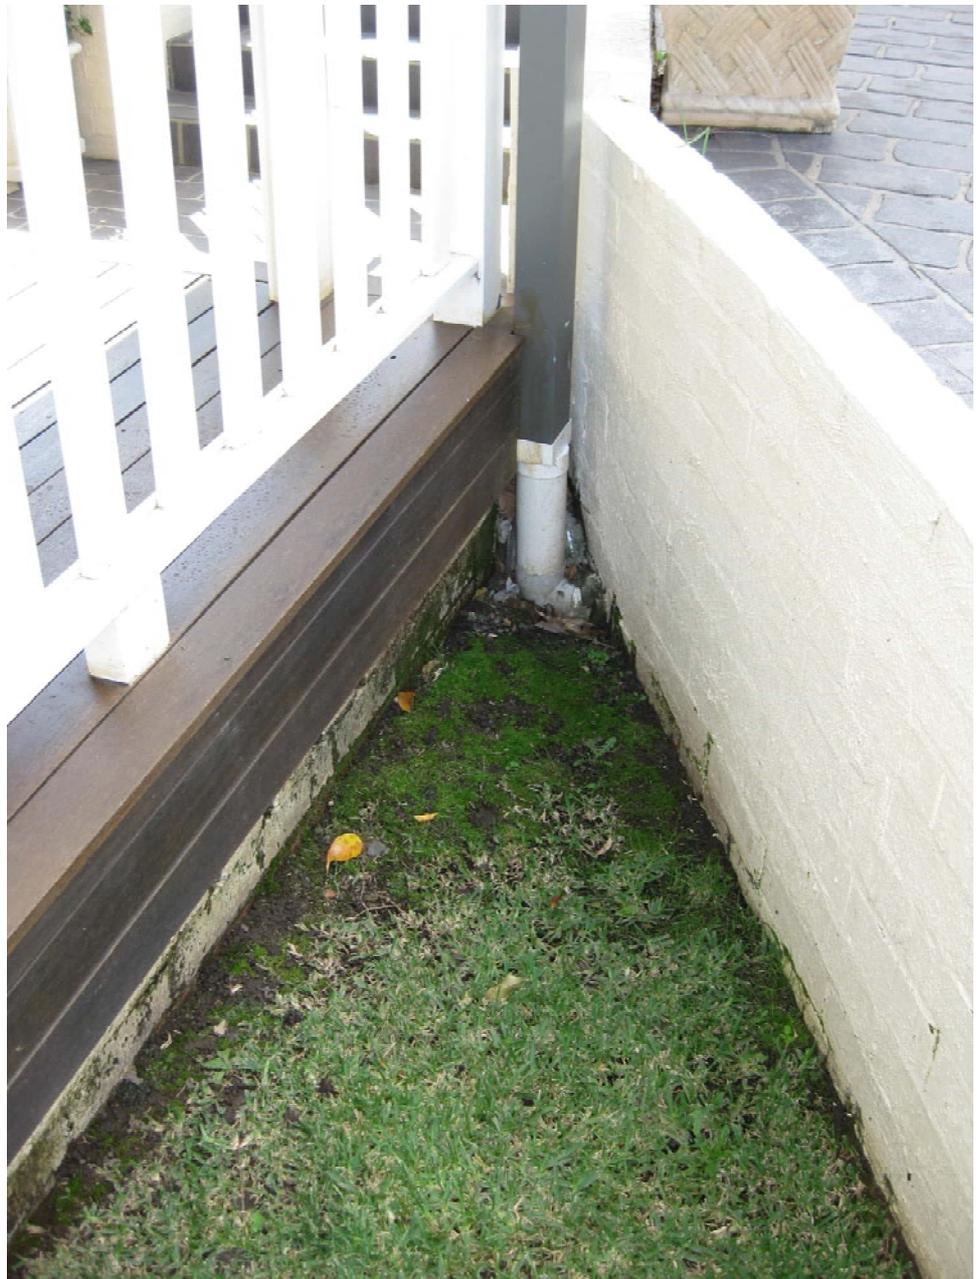
**Evidence of damp condition at interface of driveway and rear verandah. This may be due to leakage from the downpipe/stormwater and should be further investigated by licensed plumber.**

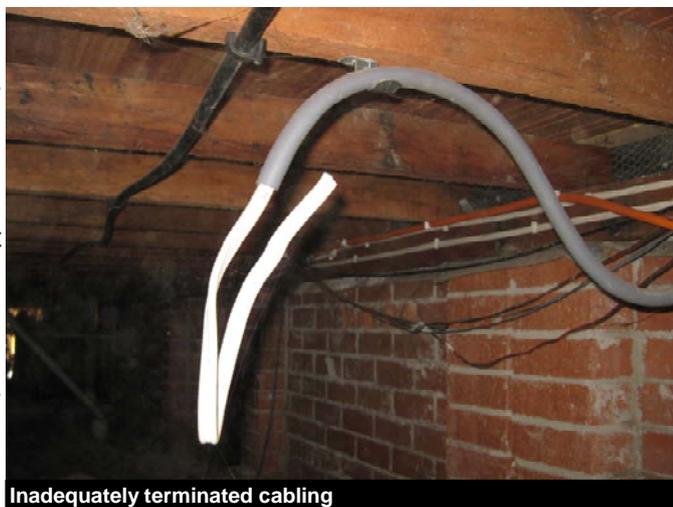
Inadequately terminated cabling

**Inadequately terminated electrical cable was identified under the family room. Further testing will need to be carried out by licensed electrician.**

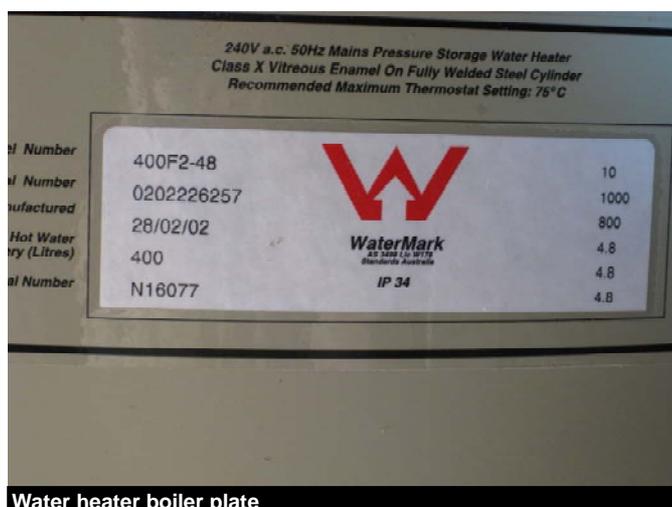
Water heater boiler plate

Heater capacity: 400L. It is a mains electric hot water system and is off-peak. The heater is under mains pressure. It is located under the house. The hot water system appears to be in working condition. No specific tests other than running the hot water from a tap was carried out. No determination has been made as to the suitability or adequacy of the hot water system in relation to capacity or otherwise. There does not appear to be a temperature control valve fitted to the water heater. A burn/scald injury is possible. It is recommended that a temperature control valve
