South Coast
Home✓Check

PROPERTY INSPECTION REPORT

YOUR REF + REPORT No: 7226

1.4 DATE OF
INSPECTION: 27-Apr-11.

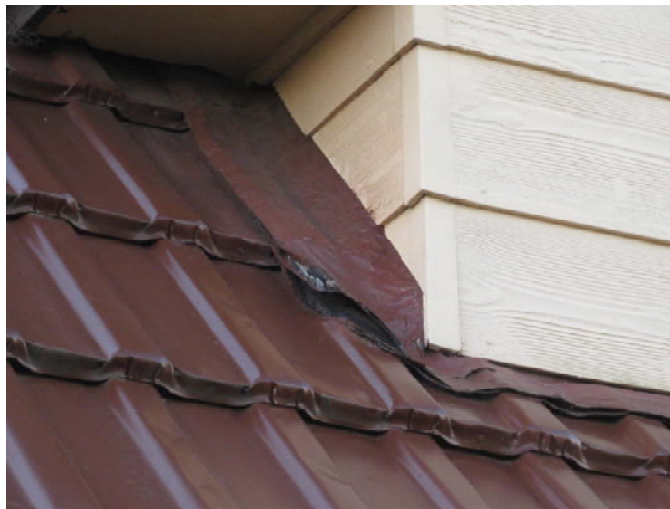
Flashings appear to be in a partly serviceable condition. It should be noted that flashings are only viewed from a distance in some areas and sometimes defects are very small and not clearly visible.

The potential for water entry is present to several sections of the apron and change of pitch flashings expressly to the dormer windows and rear first floor skillion roof. This should be fully investigated by a licenced roof plumber.

Lifting and ill fitted flashings.

2.6 The following action is recommended:

A licensed roof plumber should be called to make a further evaluation and repairs or rectification as needed.

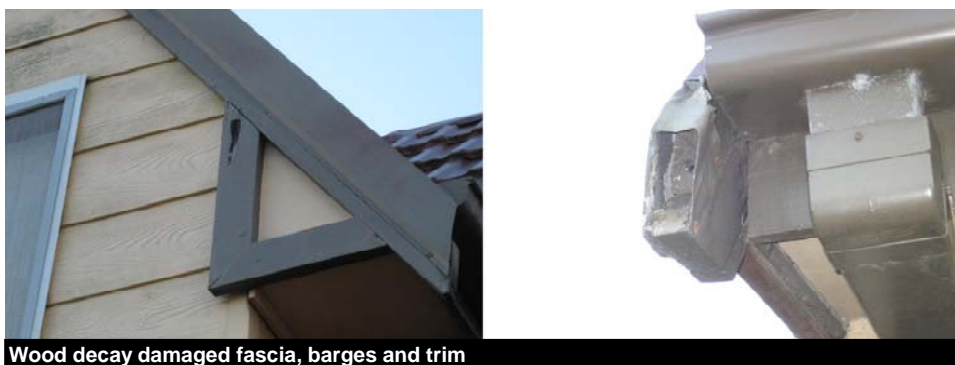
Wood decay damaged fascia, barges and trim

The overall condition of the fascias/bargeboards is poor to fair.

Moderate to severe wet rot decay is present to timber fascias, barge boards and associated timber trim. Maintenance or replacement is required.

The paint work is deteriorating and maintenance is required.

It is recommended to use an external grade premium paint to assist in preventing premature failure of the said items, and be repaired when necessary with known durable (exterior) timbers.

2.10 The following action is recommended:

A licensed carpenter should be called to make a further evaluation and repairs or rectification as needed. A licensed painter should be called to make a further evaluation and repairs or rectification as needed.

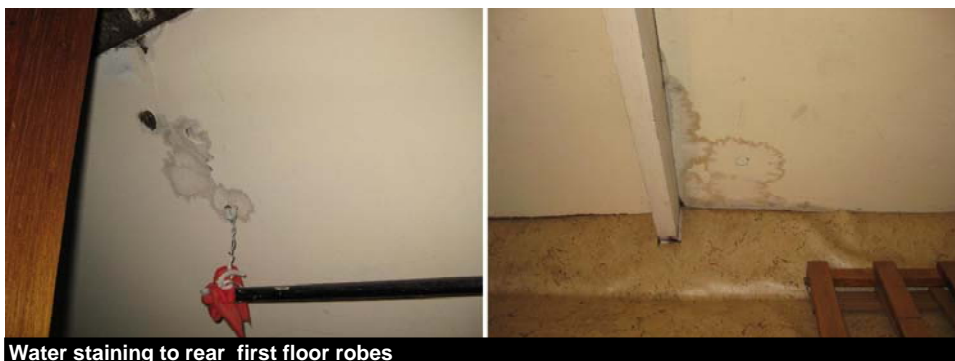
3.7 Area: Leaks from the roof were identified above the following areas: some localised sections of the rear addition along with some localised sections of the main roof (see also roof system external - flashings)

Water staining to rear first floor robes

Evidence of water penetration from the roof was noted to the rear of the first floor bedroom robes & to the southern side ceiling of bedroom 3. See notes in Roof System External.

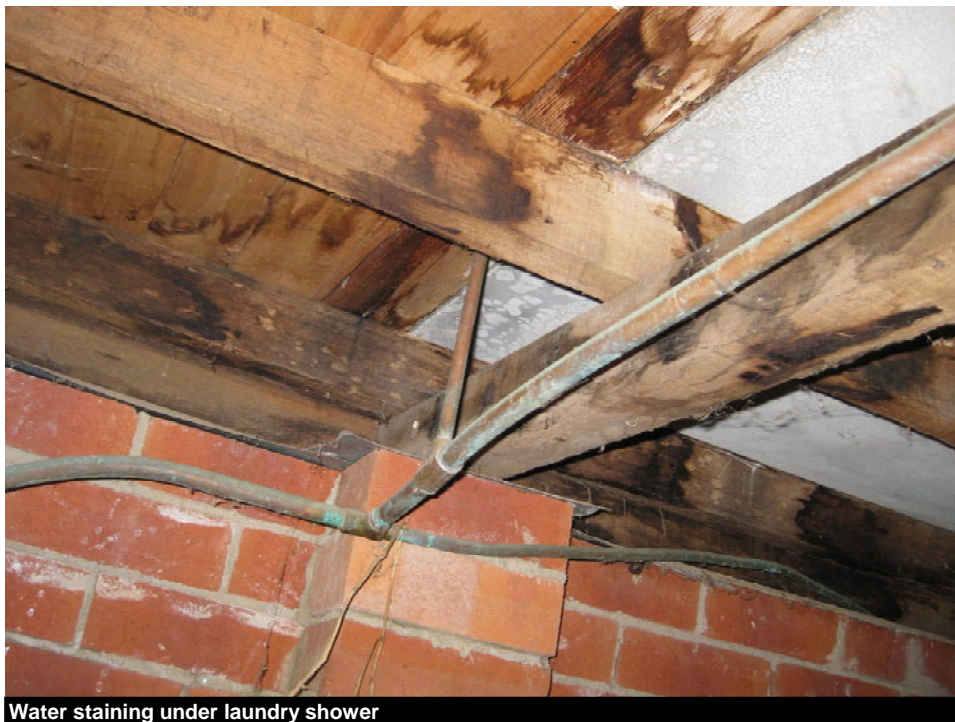
Water staining under laundry shower

The shower recess was tested and there was no visible water penetration to surrounding areas, however some obvious water staining was noted to timber flooring abutting the laundry (viewed from subfloor). **IMPORTANT NOTE:** This test may not reveal water leaks until the shower is put into constant use and surrounding areas monitored over a period of time.

The shower recess presents indications of having sustained a past leak (this may be in the form of water damage/staining to areas outside of the shower, along with a different shade of tile to the shower recess). Past repairs may have been carried out. A further investigation (by a competent person such as a licensed plumbing & waterproofing contractor) is recommended to determine the integrity of the waterproofing and water service.

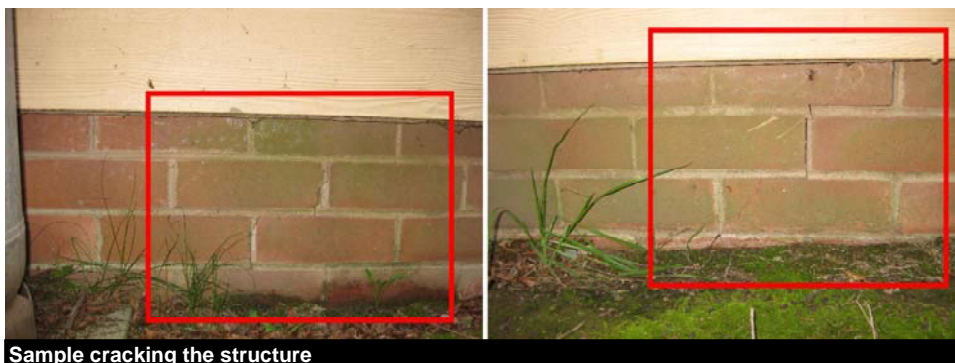
Sample cracking the structure

Varying degrees of cracking and movement are evident to all sides of the brick foundation walls. Visible cracking has been categorized as a structural defect. Cracking of a building element is a structural defect where in the opinion of the inspector the structural performance of the building element is impaired, or where the cracking is the result of the structural behavior of the building. The expected consequence of this cracking is unknown until further information is obtained.

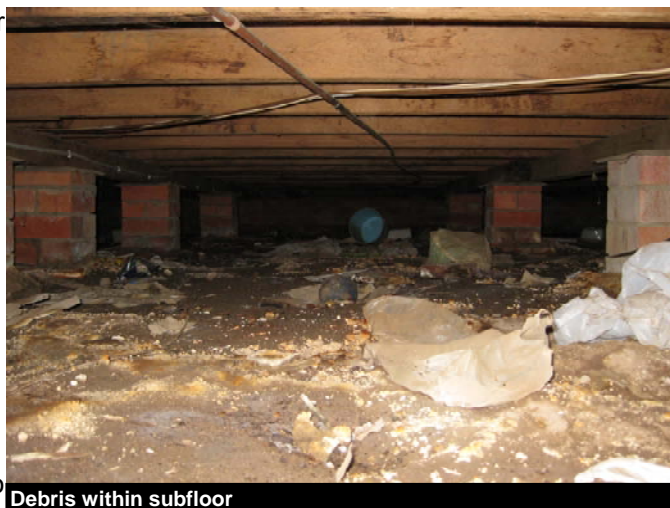
Debris within subfloor

Saturated soil and ponding water prevented full body access being gained below the eastern quarter of the subfloor.

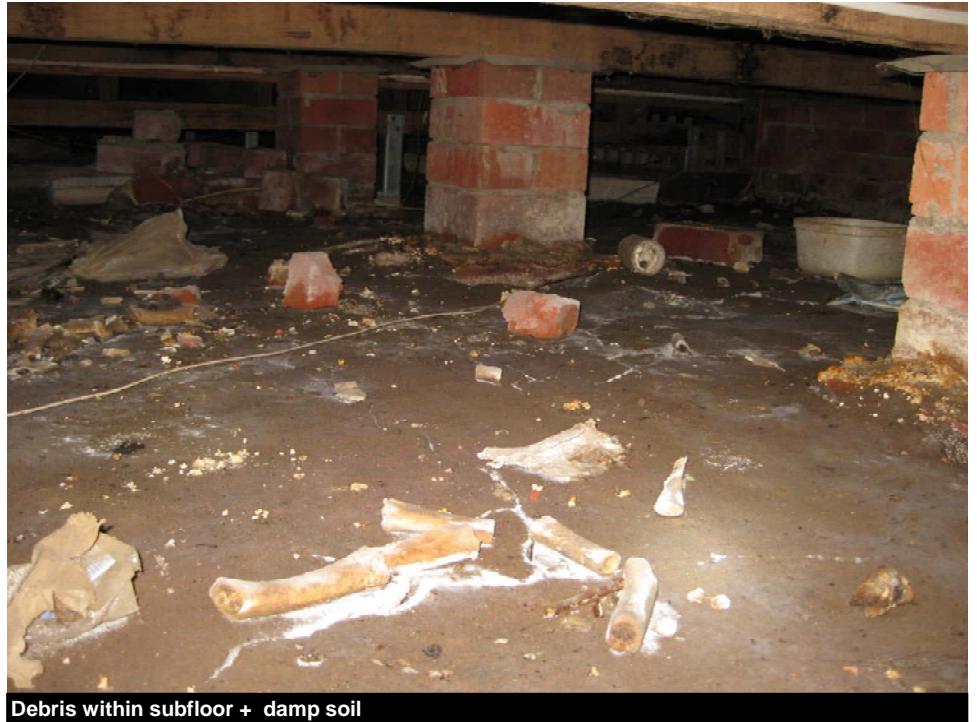
Debris within subfloor + damp soil

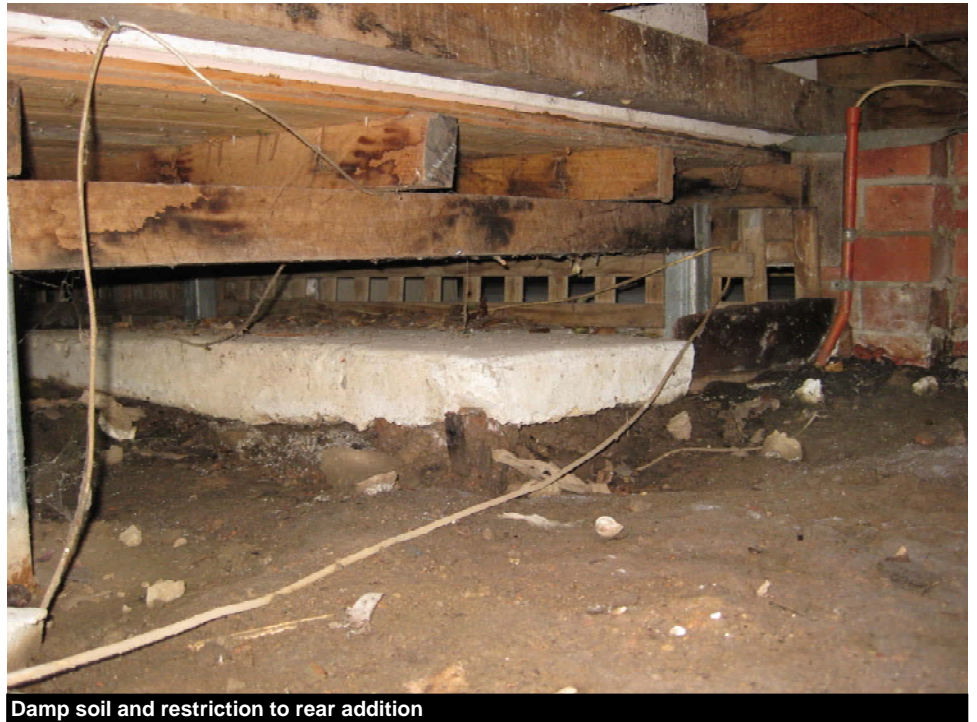
Damp soil and restriction to rear addition

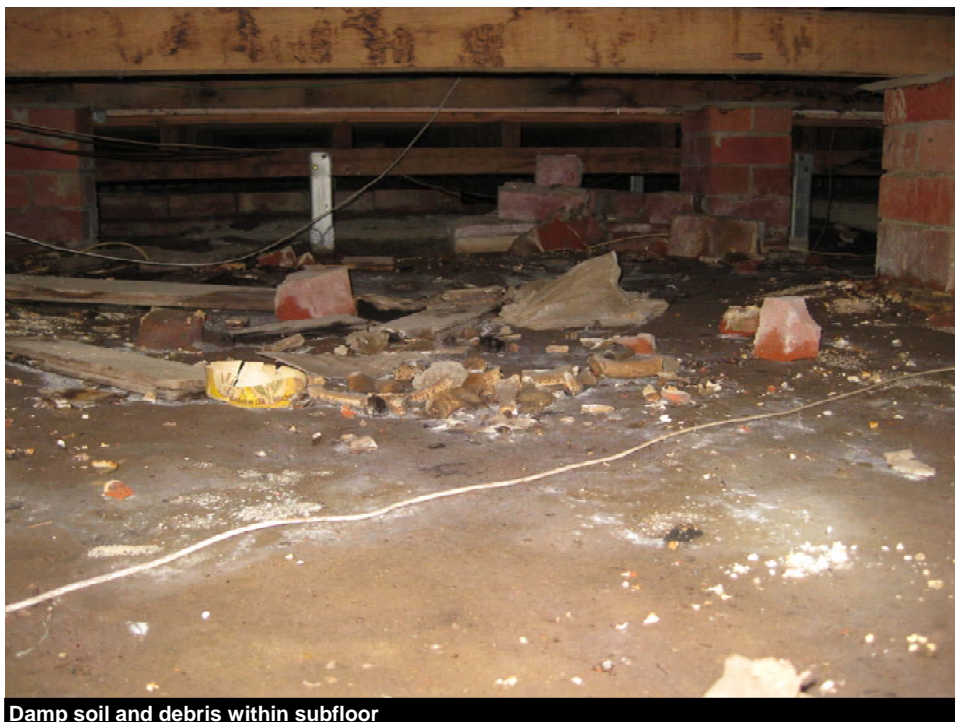
Damp soil and debris within subfloor

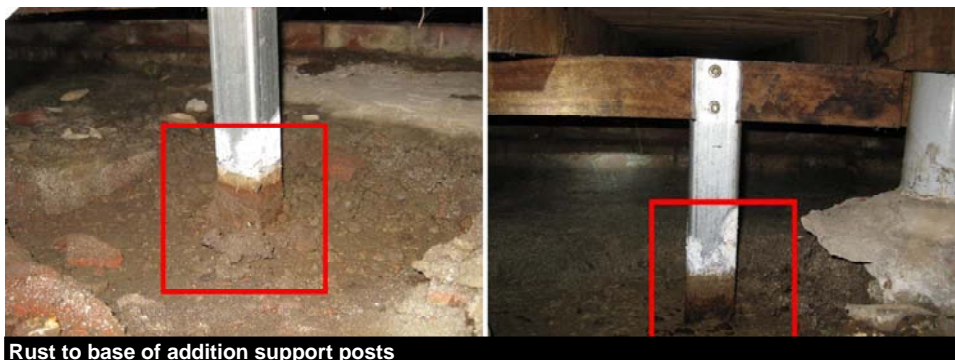
Rust to base of addition support posts

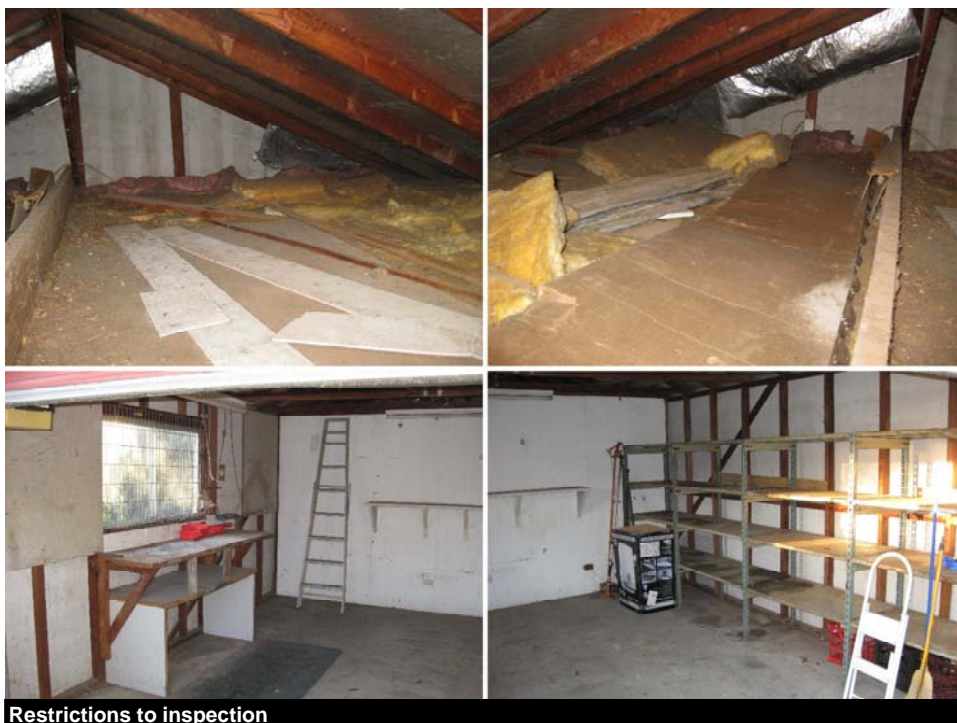
Restrictions to inspection

Stored items and shelving partly restricted inspection to the interior. Stored items should be removed to enable a more complete report to be submitted.

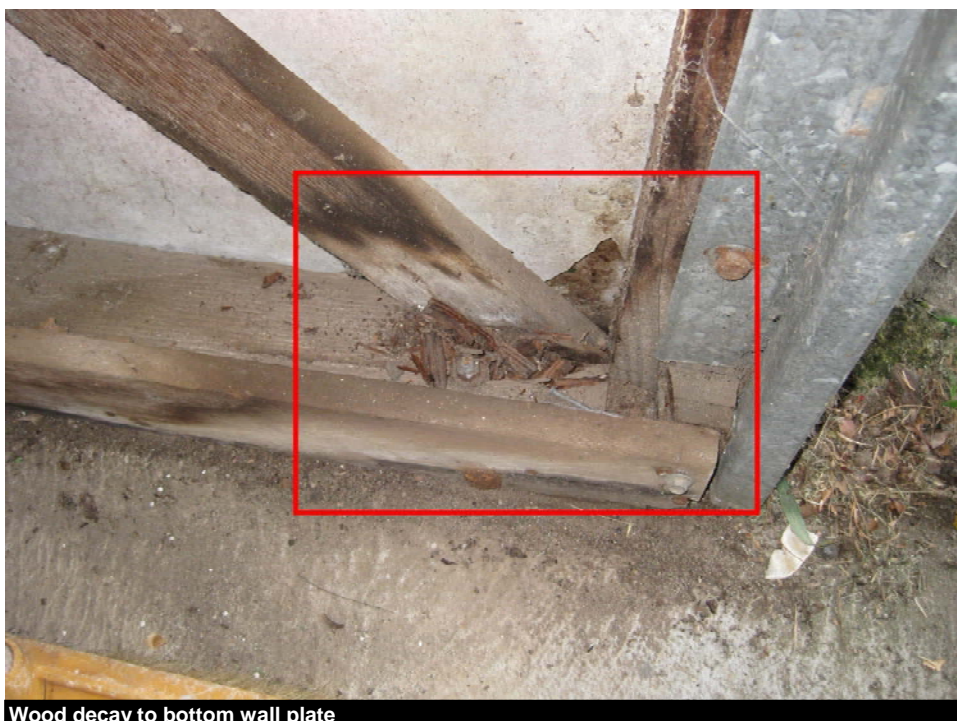
Wood decay to bottom wall plate

Moderate to severe wood decay damage was noted to the southern side bottom wall plates. Repairs may be required.

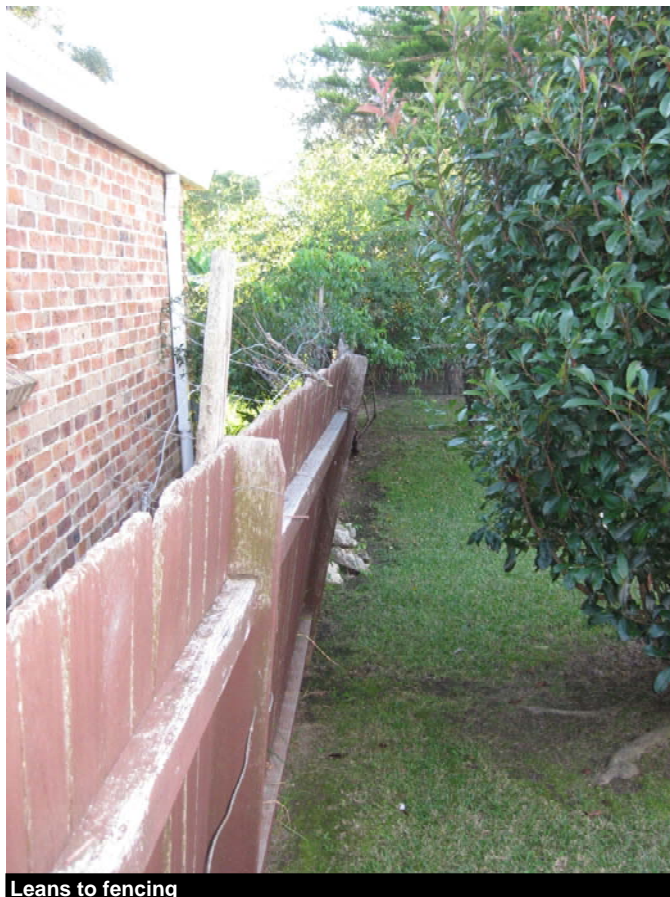
The lot is fenced on, three sides. The fences are mainly constructed from timber. **The fences are generally in poor to fair condition and repairs or replacement is required.** Several fencing panels sustain leans to varying degrees. It is recommended to re-plumb the affected sections.

Leans to fencing
